INTERNAL RUDDER BELHORN INSTALLATION

PERPENDICULAR (BOTTOM MOUNTED) METHOD

This write-up describes the installation of the internal (hidden) rudder belhorn in Rutan Aircraft Factory's Long-EZ Internal Rudder Belhorn plans. This method is similar to the RAF method, but with two main differences: the belhorn was installed perpendicular (i.e. at 90 degrees) to the hinge axis, and it was mounted at the bottom of the rudder core.

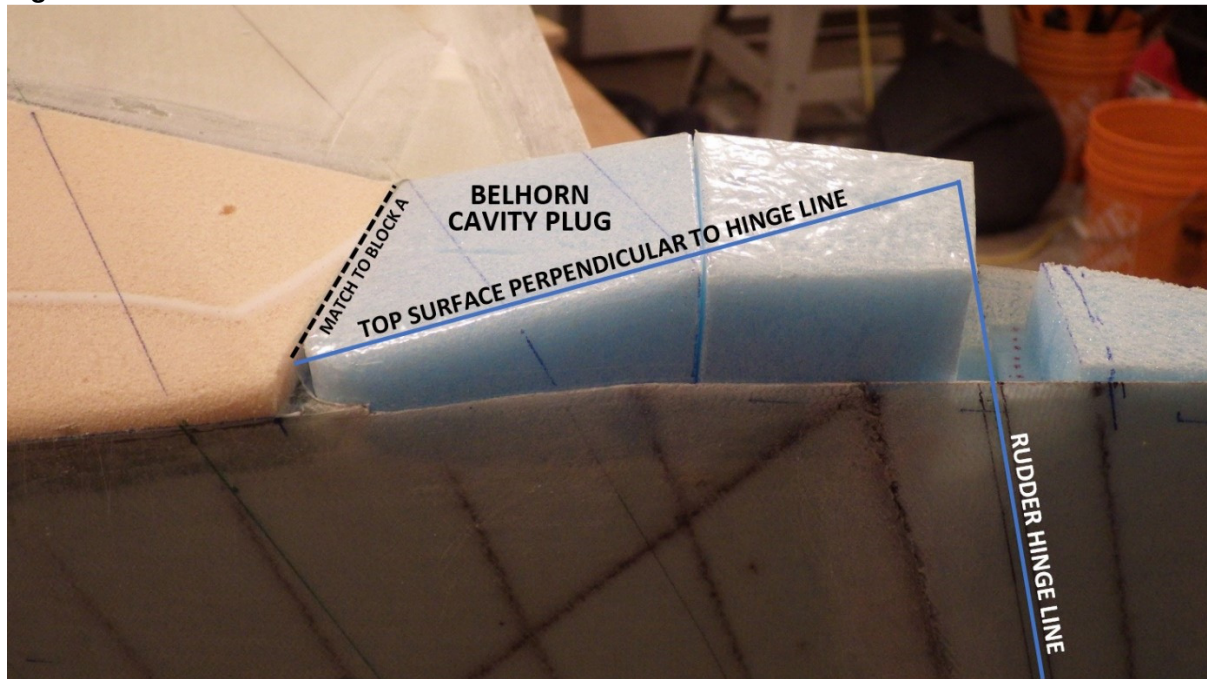
A piece of scrap polystyrene (blue) foam was used to make a plug that would form the inside of the belhorn cavity. The outboard edge of this plug was rounded just enough to allow fiberglass (layup #3) to conform over it. (Since any material removed from the plug reduces the size of the cavity that it will form, rounding the edge too much could later create interference that will limit belhorn deflection.) The plug was shaped to fit snug into the 1/2-inch-deep depression that was milled out of the winglet. The forward height of the plug was matched to block A, so their top mating edges met the top corner of the conduit cove. (Figure 7) The plug sloped back toward the TE at an angle perpendicular to the hinge line.

Figure 7 shows the plug made of two blocks, but this can be a single block that extends far enough aft to fully support layup #3. (At the time, the method was still being developed and it was determined that the first plug would be too short, so an extension was added. This can be seen in figure 8 where removal of the second block reveals the triangular section of the layup that would have been unsupported without it.)
